PACSystems* RX7i

IC698CPE030-JP/CPE040-JP

Central Processing Unit

GFK-2438W

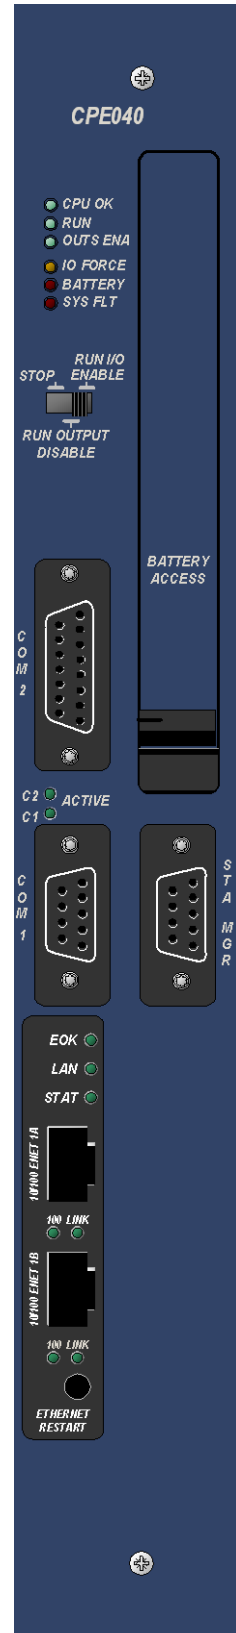
The RX7i CPUs are programmed and configured by the programming software to perform real time control of machines, processes, and material handling systems. The CPU communicates with I/O and smart option modules over a rack-mounted backplane using the VME64 Standard format. It communicates with the programmer and HMI devices via the embedded Ethernet ports or a serial port using SNP Slave protocol.

CPE030: 600MHz Pentium-M microprocessor with 64 MB of user memory and 64 MB of user flash

CPE040: 1800MHz Pentium-M microprocessor with 64 MB of user memory and 64 MB of user flash

- Full programming and configuration services
 - Comprehensive station management and diagnostic tools
 - Two full-duplex 10BaseT/100BaseT/TX (RJ-45 Connector) ports with an internal network switch providing auto-negotiated network speed, duplex mode, and crossover detection.
